Ship Unloader Crane Removal

Specification Booklet

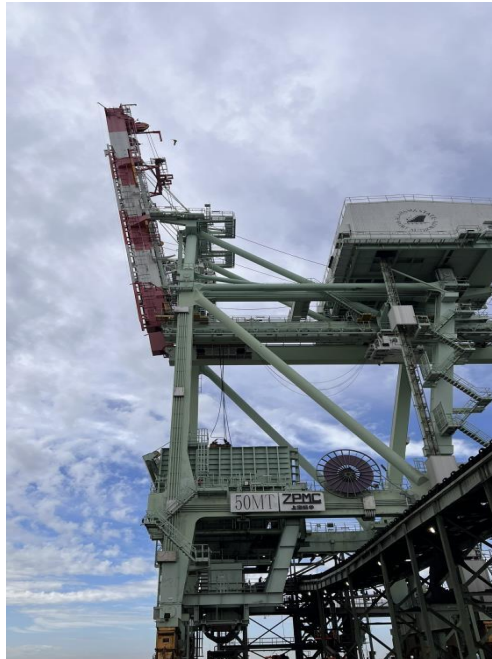
**Pre-Demolition Hazardous Materials Survey
Alabama Port Authority
McDuffie Terminal - S-Crane, M-Crane, and Z-Crane
2001 Ezra Trice Blvd
Mobile, AL 36603**
